**Flood Control Project Maintenance  
Levee Inspections**

## Maintenance Issue Types Only, Levee Inspection Report By Mile - Fall 2015

### Reclamation District No. 0404 Boggs

Waterway	Bank	Unit Miles	Inspection Start/End	Inspector
Unit No. 01 San Joaquin River	Right	2.35	10/15/2015 10/15/2015	Richard Willoughby

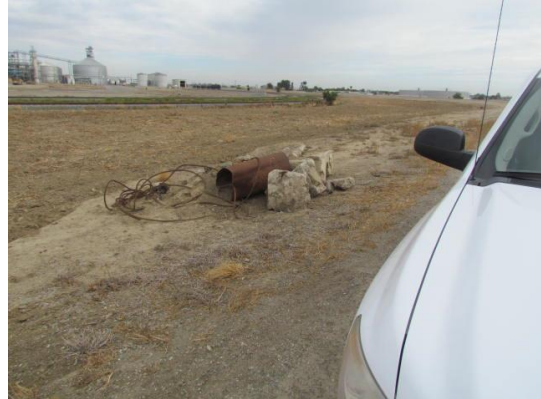
Photo 1 of 1 : FA\_2015\_RD0404\_305\_31\_20151019\_00029.jpg

LM Start	0.13	Rating **	M	Issue No.	31
LM End	0.13	Issue Type +	Ma	Location *	LS
Category	Earthen Levee			GPS Latitude/Longitude	
				Start	End
Item	Encroachments			37.940677 °	37.940677 °
				-121.343790 °	-121.343790 °
DWR ID	DWR_RD0404_01_s _ 2015_31				
Action/Comments					
Material Inspector Comments: Remove the large concrete blocks from landward slope.

Looking southeast at concrete blocks on landward slope.

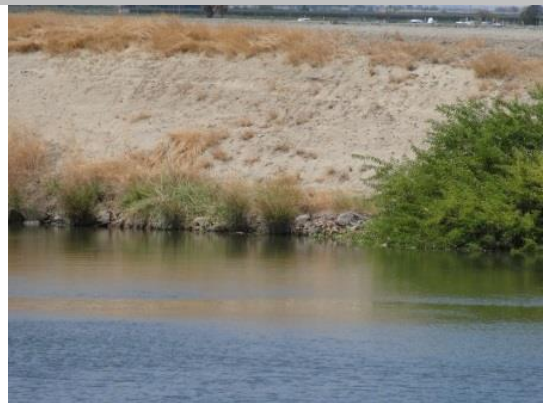
Photo 1 of 2 : SJR2015\_RD0404U01RM41.11\_3.jpg

LM Start	0.34	Rating **	U	Issue No.	9
LM End	0.34	Issue Type +	Ma	Location *	WS
Category	Supplemental			GPS Latitude/Longitude	
				Start	End
Item	DWR Erosion Survey			37.939190 °	37.939190 °
				-121.338280 °	-121.338280 °
DWR ID					
Action/Comments					
Inspector Comments: 06/24/2015: No significant change observed. 6/19/2014: No significant change observed. 08/13/2013: No significant change at this site. 8/7/2012: The erosion is next to a repaired site and approximately 400 feet downstream of a river bend. There are broken concretes at the upper levee slope, but not visible at the levee toe or lower slope. Likely

Close view of the site.

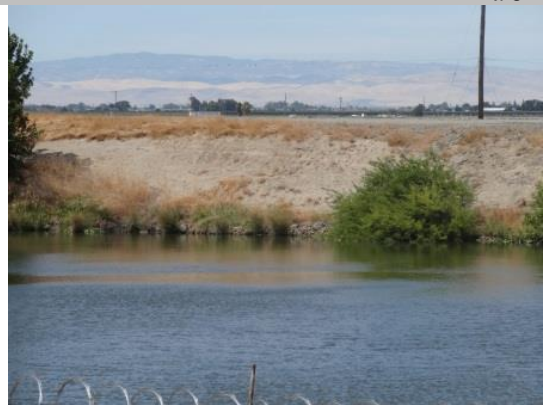
Photo 2 of 2 : SJR2015\_RD0404U01RM41.11\_5.jpg

A closer view of the site.

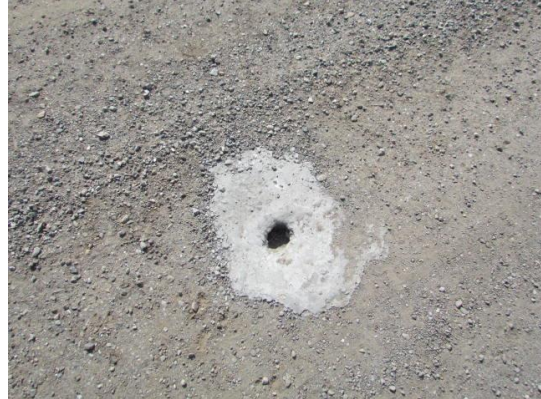
Photo 1 of 4 : FA\_2015\_RD0404\_305\_5\_20150914\_00004.jpg

LM Start	0.43	Rating **	M	Issue No.	5
LM End	0.43	Issue Type +	Ma	Location *	CR
Category	Earthen Levee			GPS Latitude/Longitude	
				Start	End
Item	Animal Control			37.939635 °	37.939635 °
				-121.339063 °	-121.339063 °
DWR ID	DWR_RD0404_01_s_2013_5				
Action/Comments					
No rodents visible, but rodent burrows visible; need to backfill and compact or grout burrows.					
Inspector Comments: District grouted hole, and the deficiency still exist.

Looking at partialled grouted rodent hole on levee crown (Fall 2014).

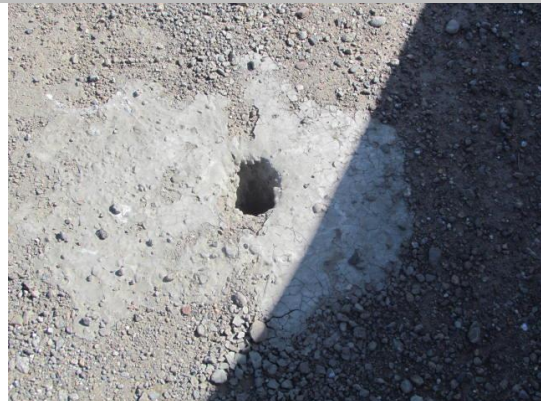
Photo 2 of 4 : FA\_2015\_RD0404\_305\_5\_20150914\_00005.jpg

Looking at partially grouted rodent hole on levee crown

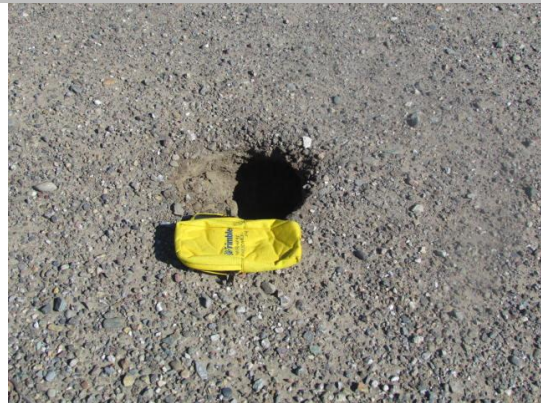
Photo 3 of 4 : FA\_2015\_RD0404\_305\_5\_20150914\_00006.jpg

Looking at rodent hole on levee crown.

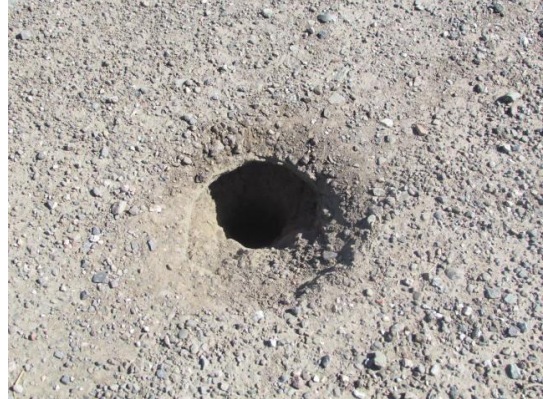
Photo 4 of 4 : FA\_2015\_RD0404\_305\_5\_20150914\_00007.jpg

LM Start	0.43	Rating **	M	Issue No.	5 (cont)
LM End	0.43	Issue Type +	Ma	Location *	CR
Category	Earthen Levee			GPS Latitude/Longitude	
				Start	End
Item	Animal Control			37.939635 °	37.939635 °
				-121.339063 °	-121.339063 °
DWR ID	DWR_RD0404_01_s_2013_5				
Action/Comments					
No rodents visible, but rodent burrows visible; need to backfill and compact or grout burrows.					
Inspector Comments: District grouted hole, and the deficiency still exist.

Looking at one of several rodent holes on levee crown.

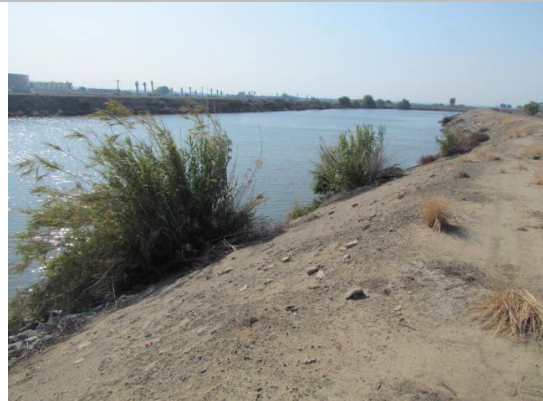
Photo 1 of 3 : FA\_2015\_RD0404\_305\_104\_20150914\_00022.jpg

LM Start	0.45	Rating **	M	Issue No.	104
LM End	0.45	Issue Type +	Ma	Location *	WS
Category	Earthen Levee			GPS Latitude/Longitude	
				Start	End
Item	Vegetation			37.939627 °	37.939627 °
				-121.338808 °	-121.338808 °
DWR ID	DWR_RD0404_01_s_2012_104				
Action/Comments					
Remove the wild growth other than native grasses from the levee slopes. Inspector Comments: Remove bamboo on waterside toe. Bamboo is not within twenty feet zone, but should be removed to stop from spreading along waterward slope. Bamboo has increased in size.

Looking northwest at bamboo on waterside toe.

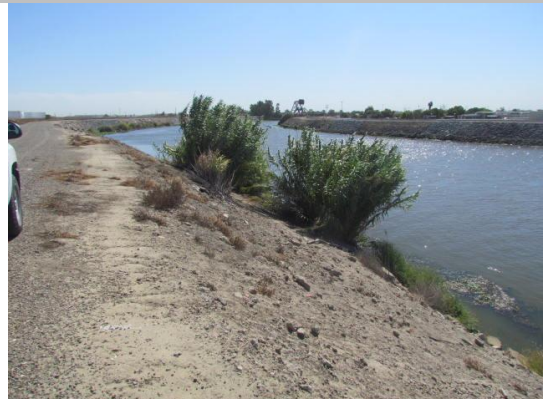
Photo 2 of 3 : FA\_2015\_RD0404\_305\_104\_20150914\_00023.jpg

Looking west at bamboo on waterward slope. 2013

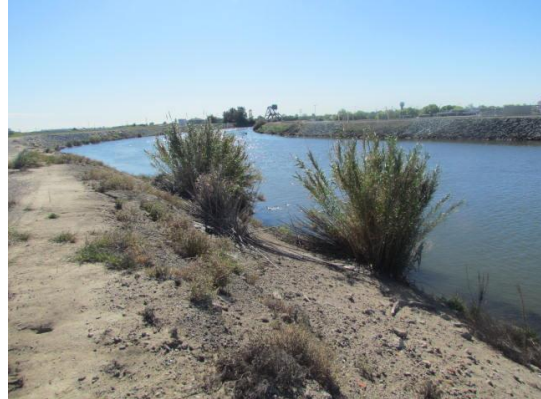
Photo 3 of 3 : FA\_2015\_RD0404\_305\_104\_20150914\_00024.jpg

LM Start	0.45	Rating **	M	Issue No.	104 (cont)
LM End	0.45	Issue Type +	Ma	Location *	WS
Category	Earthen Levee			GPS Latitude/Longitude	
				Start	End
Item	Vegetation			37.939627 °	37.939627 °
				-121.338808 °	-121.338808 °
DWR ID	DWR_RD0404_01_s _ 2012_104				
Action/Comments					
Remove the wild growth other than native grasses from the levee slopes. Inspector Comments: Remove bamboo on waterside toe. Bamboo is not within twenty feet zone, but should be removed to stop from spreading along waterward slope. Bamboo has increased in size.

Looking southwest at bamboo on waterward slope and toe.

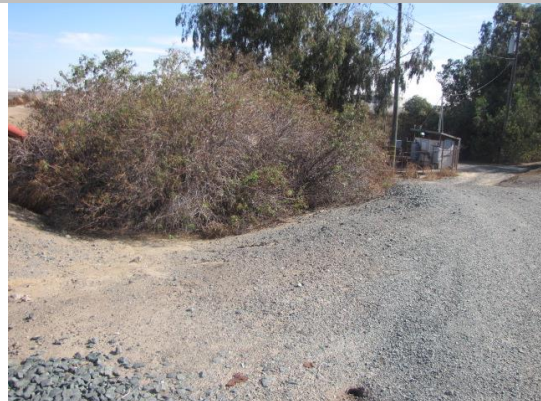
Photo 1 of 1 : FA\_2015\_RD0404\_305\_7\_20150914\_00008.jpg

LM Start	0.75	Rating **	M	Issue No.	7
LM End	0.75	Issue Type +	Ma	Location *	LS
Category	Earthen Levee			GPS Latitude/Longitude	
				Start	End
Item	Vegetation			37.937758 °	37.937758 °
				-121.334149 °	-121.334149 °
DWR ID	DWR_RD0404_01_s _ 2012_7				
Action/Comments					
Elderberries are blocking visibility and flood fight capability.

Looking southeast at elderberry on landside slope.

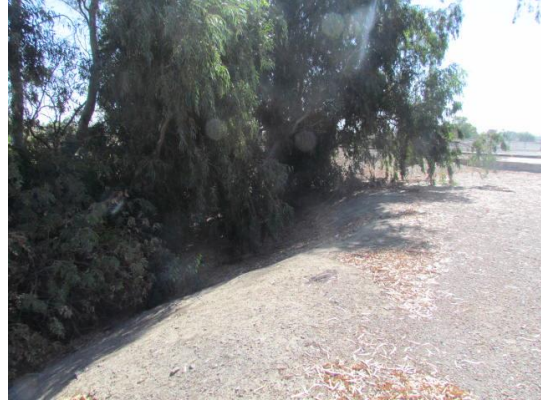
Photo 1 of 1 : FA\_2015\_RD0404\_305\_8\_20150914\_00009.jpg

LM Start	0.78	Rating **	M	Issue No.	8
LM End	0.78	Issue Type +	Ma	Location *	LS
Category	Earthen Levee			GPS Latitude/Longitude	
				Start	End
Item	Trim / Thin Trees			37.937395 °	37.937395 °
				-121.333883 °	-121.333883 °
DWR ID	DWR_RD0404_01_s _ 2013_8				
Action/Comments					
Trim trees to at least five feet above ground level.					
Inspector Comments: Trees are blocking view of the slope.

Looking southeast at dense trees on landward slope and toe.

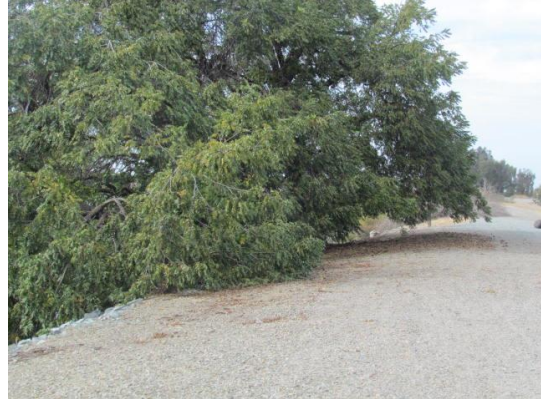
Photo 1 of 1 : FA\_2015\_RD0404\_305\_102\_20151019\_00031.jpg

LM Start	1.07	Rating **	U	Issue No.	102
LM End	1.07	Issue Type +	Ma	Location *	WS
Category	Earthen Levee			GPS Latitude/Longitude	
				Start	End
Item	Trim / Thin Trees			37.935358 °	37.935358 °
				-121.329645 °	-121.329645 °
DWR ID	DWR_RD0404_01_s_2012_102				
Action/Comments					
Trim trees to at least five feet above ground level.

Looking northwest at untrimmed tree on waterward slope.

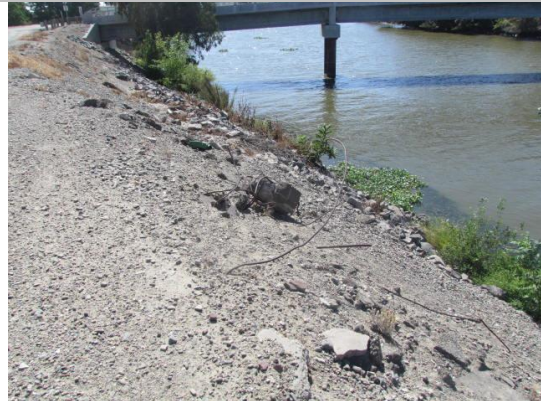
Photo 1 of 1 : FA\_2015\_RD0404\_305\_4\_20150914\_00003.jpg

LM Start	1.09	Rating **	M	Issue No.	4
LM End	1.09	Issue Type +	Ma	Location *	WS
Category	Earthen Levee			GPS Latitude/Longitude	
				Start	End
Item	Riprap Revetments			37.935158 °	37.935158 °
				-121.329365 °	-121.329365 °
DWR ID	DWR_RD0404_01_f_2013_4				
Action/Comments					
Inspector Comments: Concrete rubble with rebar should be removed.

Looking southwest at concrete rubble with rebar on waterward slope.

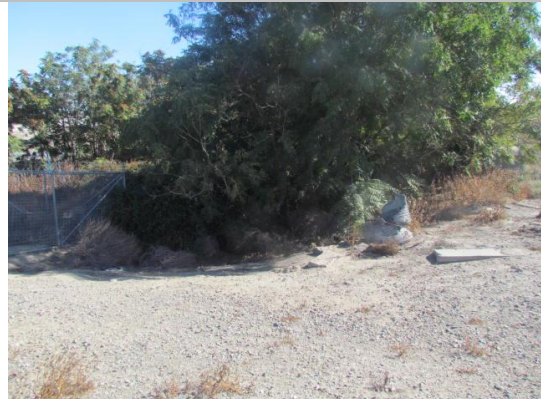
Photo 1 of 1 : FA\_2015\_RD0404\_305\_101\_20150914\_00021.jpg

LM Start	1.19	Rating **	M	Issue No.	101
LM End	1.19	Issue Type +	Ma	Location *	LS
Category	Earthen Levee			GPS Latitude/Longitude	
				Start	End
Item	Vegetation			37.934058 °	37.934058 °
				-121.328188 °	-121.328188 °
DWR ID	DWR_RD0404_01_s_2012_101				
Action/Comments					
Remove the wild growth other than native grasses from the levee slopes.

Looking southeast at overhanging trees on landside slope.

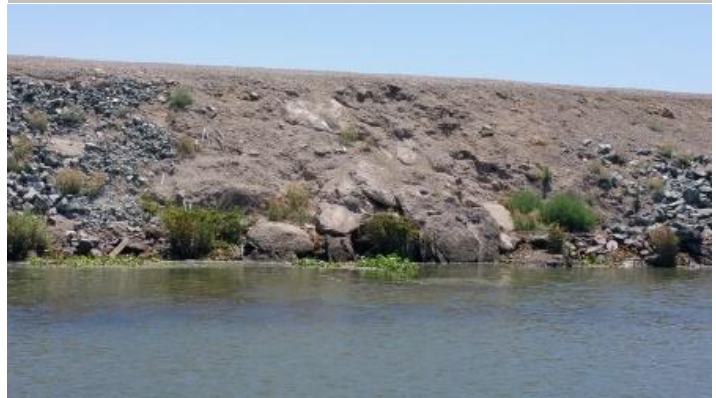
Photo 1 of 2 : SJR2015\_RD0404U01RM42.02\_1.JPG

LM Start	1.44	Rating **	M	Issue No.	11
LM End	1.46	Issue Type +	Ma	Location *	WS
Category	Supplemental			GPS Latitude/Longitude	
				Start	End
Item	DWR Erosion Survey			37.930450 °	37.930450 °
				-121.327450 °	-121.327450 °
DWR ID					
Action/Comments					
Inspector Comments: 06/24/2015: No significant change observed. 06/19/2014: A series of scarp erosions have been found on the lower levee slope and at the levee toe. [2015 Site ID:RD0404U01RM42.02]

Front view of the erosion.

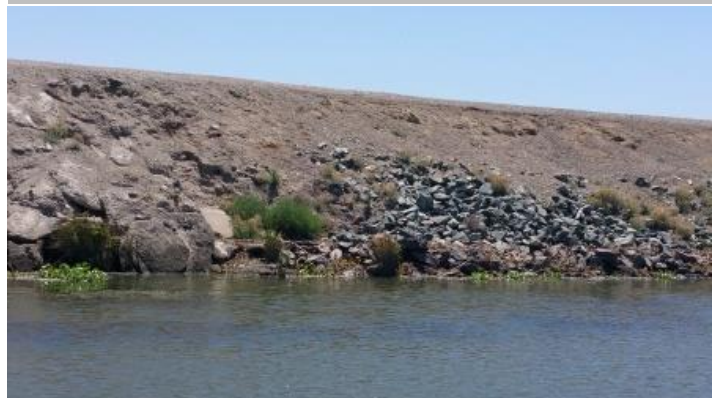
Photo 2 of 2 : SJR2015\_RD0404U01RM42.02\_3.JPG

Close view of the erosion. The upstream end of the site is protected by riprap revetment.

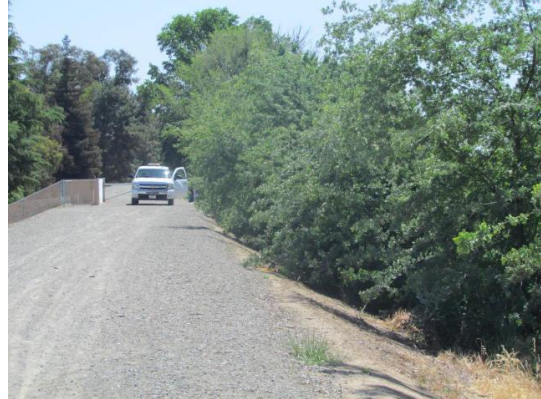
Photo 1 of 1 : FA\_2015\_RD0404\_305\_29\_20150914\_00018.jpg

LM Start	1.70	Rating **	M	Issue No.	29
LM End	1.77	Issue Type +	Ma	Location *	WS
Category	Earthen Levee			GPS Latitude/Longitude	
				Start	End
Item	Trim / Thin Trees			37.927517 °	37.926632
				-121.325515 °	-121.324868
DWR ID	DWR_RD0404_01_s_2015_29				
Action/Comments					
Trim trees to at least five feet above ground level.

Looking east at untrimmed trees on waterward slope.

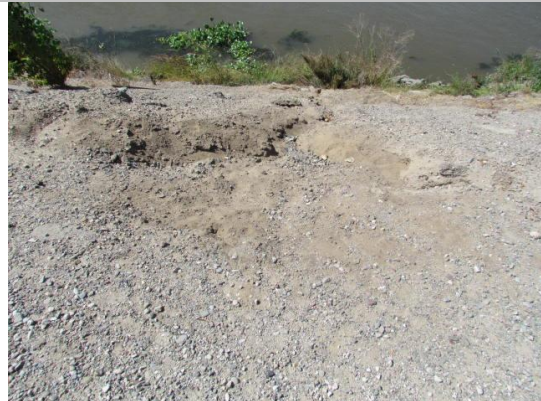
Photo 1 of 2 : FA\_2015\_RD0404\_305\_16\_20150914\_00010.jpg

LM Start	2.01	Rating **	M	Issue No.	16
LM End	2.01	Issue Type +	Ma	Location *	WS
Category	Earthen Levee			GPS Latitude/Longitude	
				Start	End
Item	Slope Stability				°
					°
DWR ID	DWR_RD0404_01_f_2013_16				
Action/Comments					
Repair the levee slope damaged by foot traffic and prevent access where possible.					
Inspector Comments: Slope damage due to foot traffic.

Looking west at slope damage due to foot traffic.

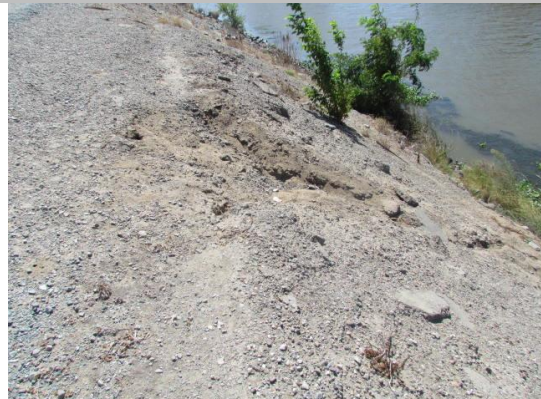
Photo 2 of 2 : FA\_2015\_RD0404\_305\_16\_20150914\_00011.jpg

Looking southwest at slope damage due to foot traffic.

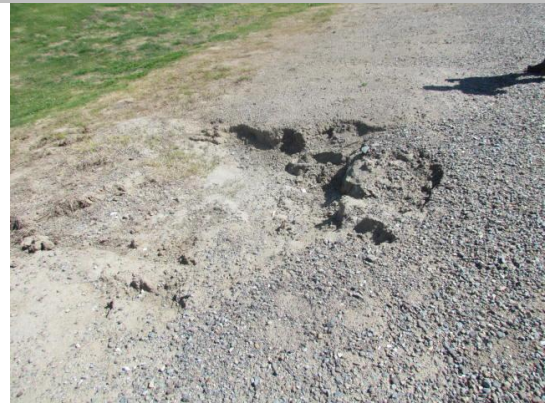
Photo 1 of 2 : FA\_2015\_RD0404\_305\_28\_20150914\_00016.jpg

LM Start	2.21	Rating **	M	Issue No.	28
LM End	2.21	Issue Type +	Ma	Location *	LS
Category	Earthen Levee			GPS Latitude/Longitude	
				Start	End
Item	Erosion / Bank Caving			37.921458 °	37.921458 °
				-121.320502 °	-121.320502 °
DWR ID	DWR_RD0404_01_s_2015_28				
Action/Comments					
Schedule repair of erosion site prior to the next inspection.					
Inspector Comments: Landward slope erosion.

Looking east at erosion on landward slope.

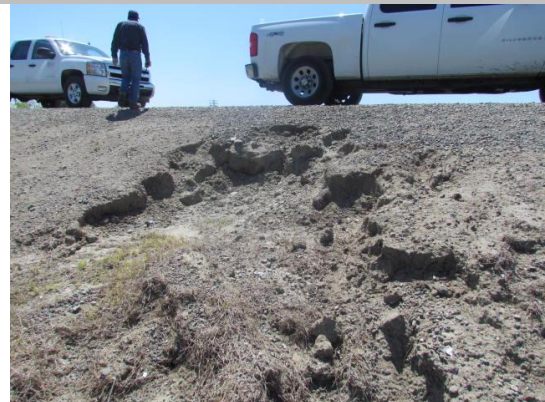
Photo 2 of 2 : FA\_2015\_RD0404\_305\_28\_20150914\_00017.jpg

Looking west at erosion on landward slope.

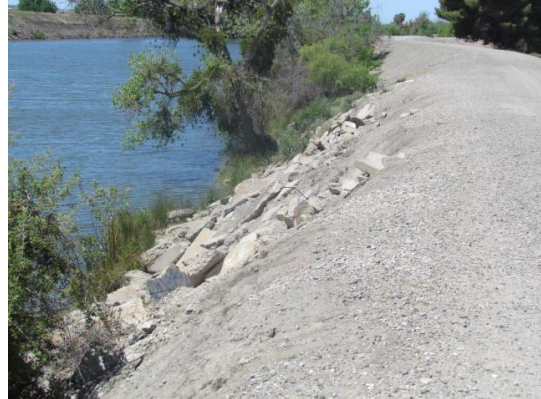
Photo 1 of 2 : FA\_2015\_RD0404\_305\_23\_20150914\_00014.jpg

LM Start	2.33	Rating **	M	Issue No.	23
LM End	2.35	Issue Type +	Ma	Location *	WS
Category	Earthen Levee			GPS Latitude/Longitude	
				Start	End
Item	Riprap Revetments			37.920488 °	37.920338 °
				-121.318630 °	-121.318435 °
DWR ID	DWR_RD0404_01_s _ 2013_23				
Action/Comments					
Inspector Comments: Remove rebar from existing concrete rip rap on waterward slope.

Looking west at concrete rip rap with rebar. (Spring 2015)

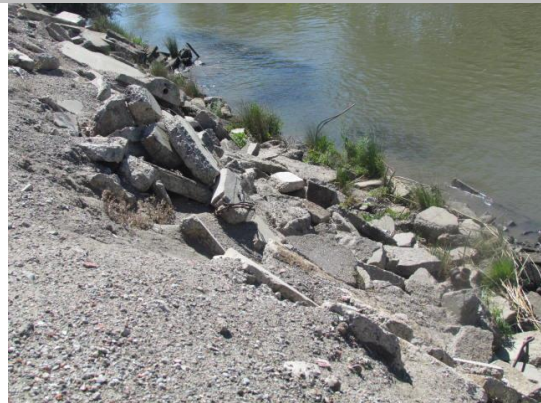
Photo 2 of 2 : FA\_2015\_RD0404\_305\_23\_20150914\_00015.jpg

Looking southwest at concrete rip rap with rebar.

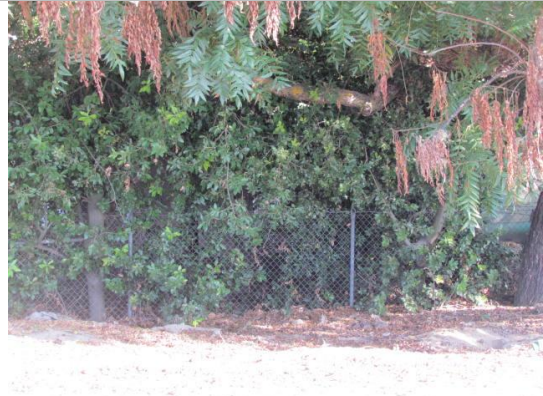
Photo 1 of 4 : FA\_2015\_RD0404\_306\_67\_20150914\_00007.jpg

Looking northeast at dense vegetation inside fenced area near pump station on landside toe.

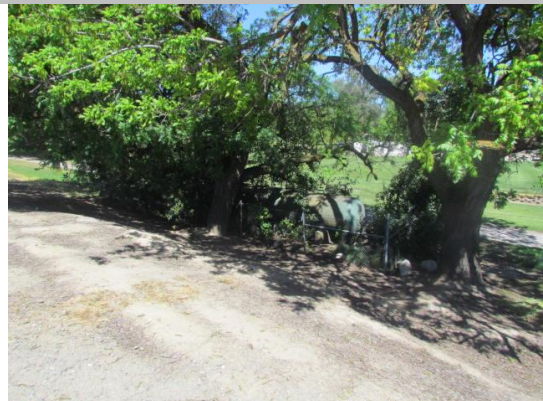
Photo 2 of 4 : FA\_2015\_RD0404\_306\_67\_20150914\_00008.jpg

Looking north at dense vegetation on landward toe around propane tank.

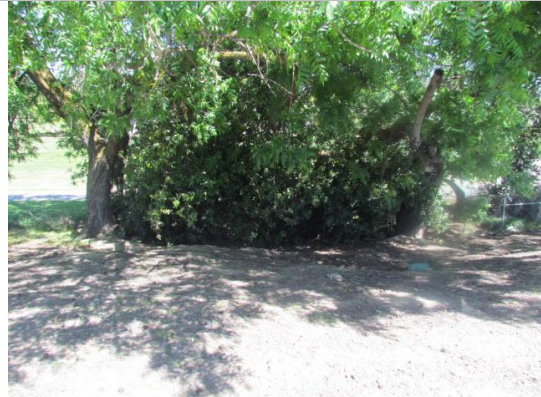
Photo 3 of 4 : FA\_2015\_RD0404\_306\_67\_20150914\_00009.jpg

Looking northeast at dense vegetation on landward toe. (Spring 2013)

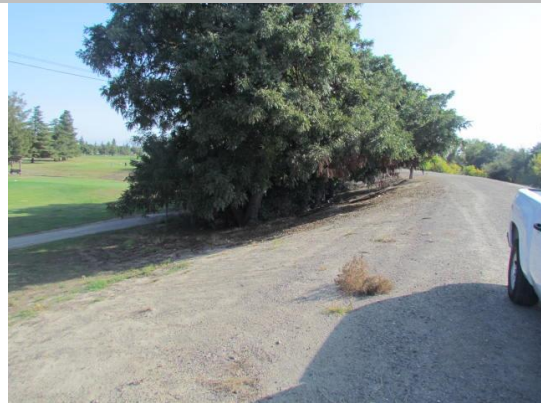
Photo 4 of 4 : FA\_2015\_RD0404\_306\_67\_20150914\_00010.jpg

Looking east at dense vegetation near pump station on landside toe.

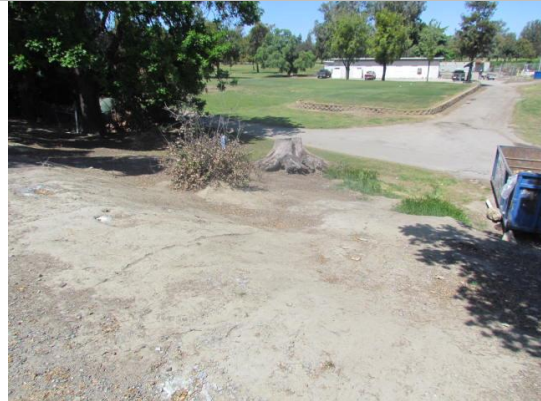
Photo 1 of 1 : FA\_2015\_RD0404\_306\_15\_20150914\_00005.jpg

Looking east at dead stump on landward toe.

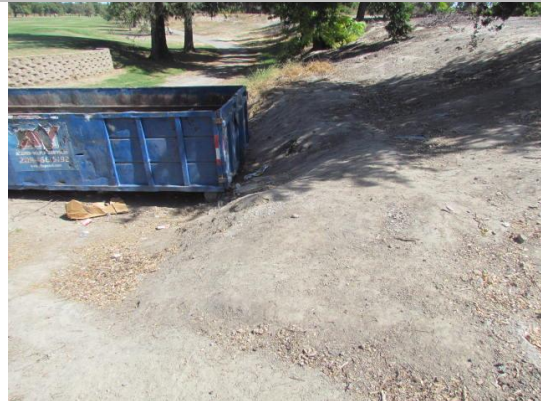
Photo 1 of 1 : FA\_2015\_RD0404\_306\_13\_20150914\_00004.jpg

LM Start	1.15	Rating **	A/W	Issue No.	13
LM End	1.15	Issue Type +	Ma	Location *	LS
Category	Earthen Levee			GPS Latitude/Longitude	
				Start	End
Item	Erosion / Bank Caving				°
					°
DWR ID	DWR_RD0404_02_f_2013_13				
Action/Comments					
Schedule repair of erosion site prior to the next inspection.					
Inspector Comments: Landside erosion from equipment placement.

Looking southeast at dumpster and landside erosion on landward toe.
